Clear Dope

JUNE 2013

Chichester and District Model Aero Club

"BLACK-WIRE" SURPRISE

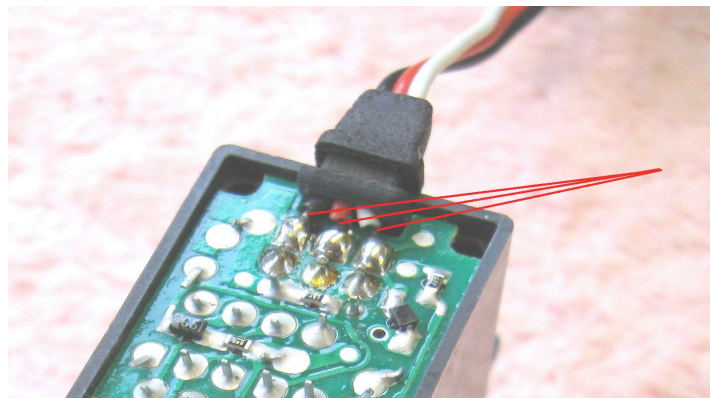
Fig 1 Black Wire Corrosion, in all its glory

Opening the servo case, I found the solder joints looking normal, but pulling-back the insulation revealed a bad case of **Black Wire Corrosion** of the copper strands. So here was the erratic connection, as further movement proved.

- The +ve and pulse leads were similarly corroded.
- There was no black wire corrosion of any of the battery or DC wiring.
- The model has been stored indoors in dry conditions, and the battery has always been kept in a good state of charge.
- The corrosion extended back about 20mm only from the solder joints. Beyond that the cable was only moderately discoloured up its whole length.
- These particular servos have given a lot of service, over a 4-1/2 year period.

So why the corrosion? The servo is virtually hermetic, so the corrosion has clearly come from inside the servo itself, and presumably the NiCd and NiMH Rx batteries used have played no part in it. I later opened-up the remaining three servos, and all were showing the same corrosion, to a slightly lesser degree.

- An aggressive flux used in making the connections? It certainly gave-off an evil odour when re-soldering, nothing like the fluxes I've been used-to in my work.
- Sulphur dissociating from the rubber grommet?
- Ozone from the worn and electrically-noisy comm/brushes of the motor? Given the correlation between sparking and ultimate failure of this servo, this could be the case, because ozone is highly corrosive to copper, and it reinforces corrosion occurring from other effects. A case for ventilation?
- A penalty of the use of bare non-plated copper conductors?

I'd seen enough by now to be convinced that I needed to replace all of the Colibrio servos with new, and opening those I found the wires to be just lightly tarnished, with the usual 0.1ohms or so of crimp resistance at this time. I gave the internal wires a coat of clear polyurethane varnish to deter further corrosion, and changed the connectors to soldered gold types for peace of mind.

It becomes clear that we should pay attention to the condition of our servo wiring, and perhaps unplug and re-plug the Rx connections from time to time. My course now with these servos is always to open them when new, varnish the wire conductors and change the connectors. That should obviate the need for periodic inspection. Listening to the motor noise with a radio provides an early warning of the next problem to face us - impending motor wear-out.
